## **RAILWAY INVESTIGATION REPORT**

**R04Q0006**

### **MAIN-TRACK DERAILMENT**

**CANADIAN NATIONAL  
FREIGHT TRAIN A-403-21-07  
MILE 77.8, MONTMAGNY SUBDIVISION  
MONTMAGNY, QUEBEC  
07 FEBRUARY 2004**

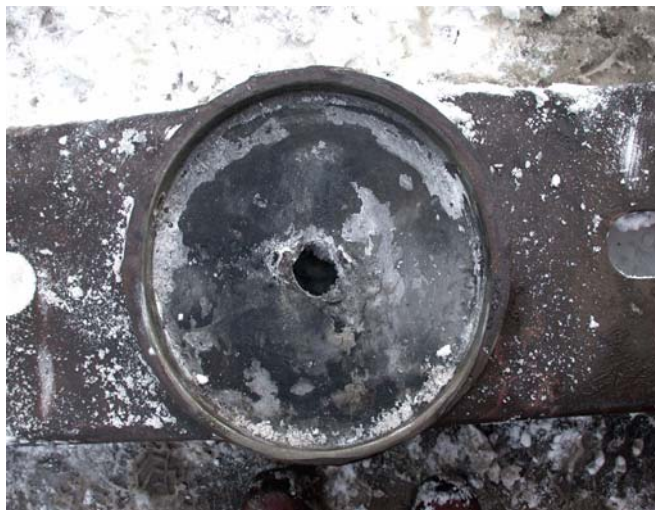
The first derailed car was an empty wood chip gondola car, CN 879261, the 7th car behind the locomotives. The car had been stripped of its brake equipment and trucks. The front portion of the body centre plate and the rim of the truck bolster centre bowl of the A-end of the car showed a matching wear pattern and polished contact faces. The centre pin holes in the centre plate casting and the body bolster were distorted in the direction of the train movement (see Photo 1). The distortion was fresh, with no corrosion present. The extensive damage to the truck and the scattering of components from similar trucks precluded its reconstruction.

**Photo 1.** Centre pin hole in the body bolster

The matching gouge marks on the truck bolster centre bowls and the centre plate on the A-end of car CN 879261 suggest that the car body centre plate had moved longitudinally and was riding on the lip of the bolster bowl. Therefore, the car body centre plate of the first derailed wood chip gondola car, CN 879261, was improperly seated in the bolster bowl. Although it is not clear that this would have made the car more susceptible to truck hunting and car body oscillation, the wear patterns and polished contact surfaces of the bolster bowl and car centre plate suggest that the trucks were subjected to high-speed truck hunting.

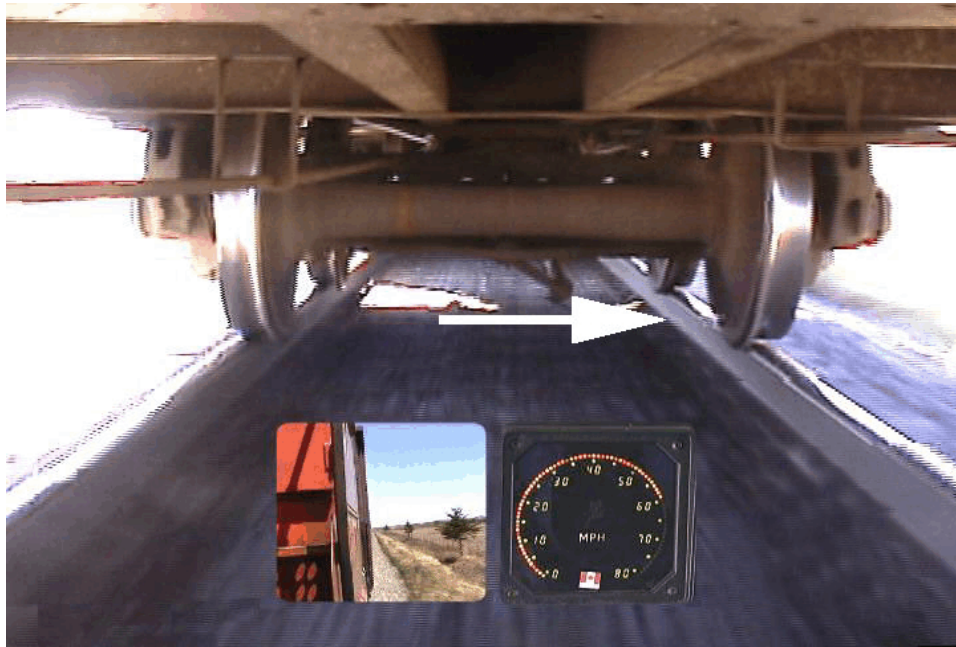
Truck hunting was observed on both test cars, with the onset beginning between 48 mph and 54 mph, depending on track condition and location. The hunting motion and car body side-to-side oscillation became more severe as speed increased, leading to visible hard flanging of the wheels, and initiation of wheel lift (see Photo 2).

**Photo 2.** Test run image showing wheel lift at 60 mph
